# Manhole Inspection Summary

Manhole # S49C\_\_030MH

Insp Date: **6/11/08 1:20 PM**

**Location** Address: **2600 e fairmount ave**

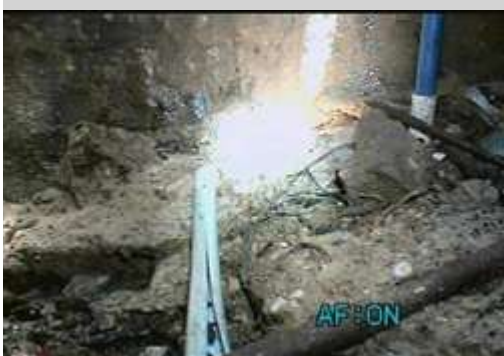
Defect 1

Infiltration: ☐ None ☐ Joint ☐ Cracks ☐ Mortar ☐ Roots ☒ **Wall**

Condition: ☐ Sound ☐ Cracked ☐ Root Intrusion ☐ Deteriorated ☐ Leaks ☒ **Debris**

Channel debris, Barrel Infiltration

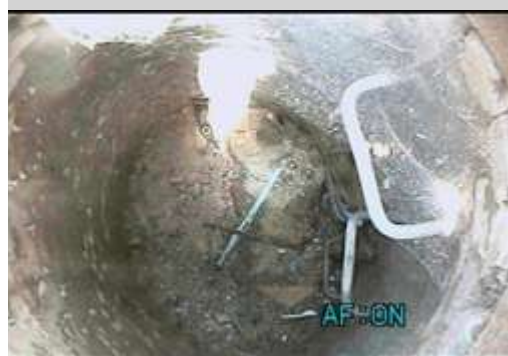
Defect 2

Condition: ☐ Sound ☐ Cracked ☐ Root Intrusion ☒ **Loose Brick** ☐ Deteriorated

**Steps** Count: **4** Missing: **0** ☒ **Corroded**

Corroded Steps, Loose Bricks in Corbel

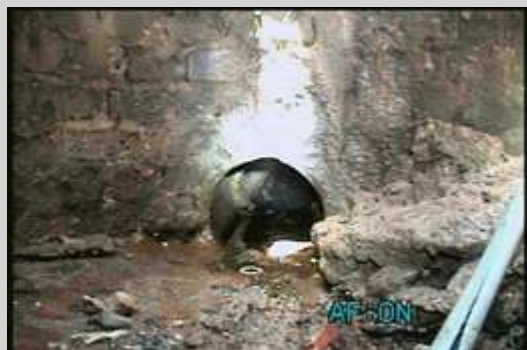
12 O'Clock Outflow

8 in. Circular Gravity Sewer  
Pipe Out @ 12 O'Clock

Invert Depth: **8.10** (ft.) Flow Characteristics: **None**

Deposits: ☒ None ☐ Mud ☐ Sludge ☐ Debris ☐ Grease

Infiltration: **None** Pipe Seal Cond: **Unknown**
